Technical Bulletin

Number: 077
Date Issued: 08/23/2010

| Subject/Key Words: | Series 4 PCs; Monitor Image Shift/Flicker; Correct Display Settings | | | |

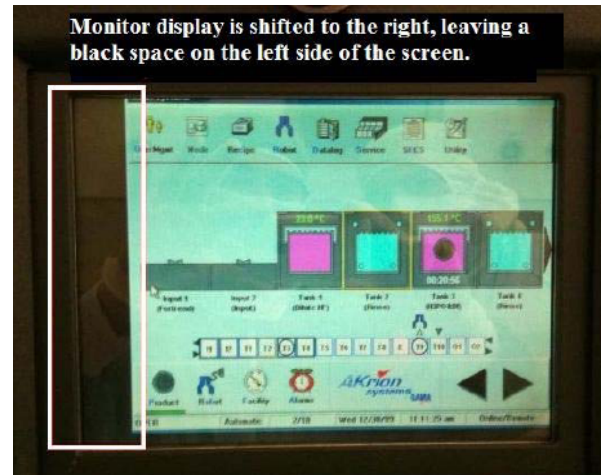
Issue: Series 4 PCs shipped to customer sites prior to August 16, 2010 had been imaged with a display setting which may result in a screen shift/reduction and possible “flicker. These symptoms have been reported on early issued UIMs (User Interface Monitor) whose monitors were supplied without any manual screen control switches.

Suspected Cause: The resolution mode was mistakenly set to 640 by 480, True Color (32 bit), 75 Hz. The 75 Hz setting causes the User Interface monitor display to shift to the right and also introduces screen “flicker”.

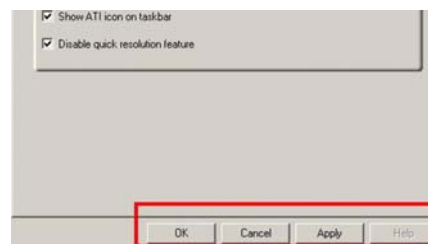
The ATI graphics utility screen does not fit on the screen at the 640x480 resolution; therefore the **OK, Cancel, and Apply** options at the bottom of the page are cut off and not displayed.

To save the settings, press the Tab key until the “**Disable quick resolution feature**” option is highlighted (a dotted line will appear around the selection). Press the Tab key once more and then press the Space bar. If prompted to save the new display properties select OK. Verify that the Screen Resolution is set to 640x480 and then close the Display properties. The User Interface screen should no longer be shifted and the Akriion software should fill the entire screen properly. The screen resolution solution setup/correction is now complete.
